# 3535 MARKET STREET WINDOW REPLACEMENT PHILADELPHIA, PA.

# CASE STUDY

Window replacement on 18-story  
medical office building; 2,496 lites  
of glass replaced.

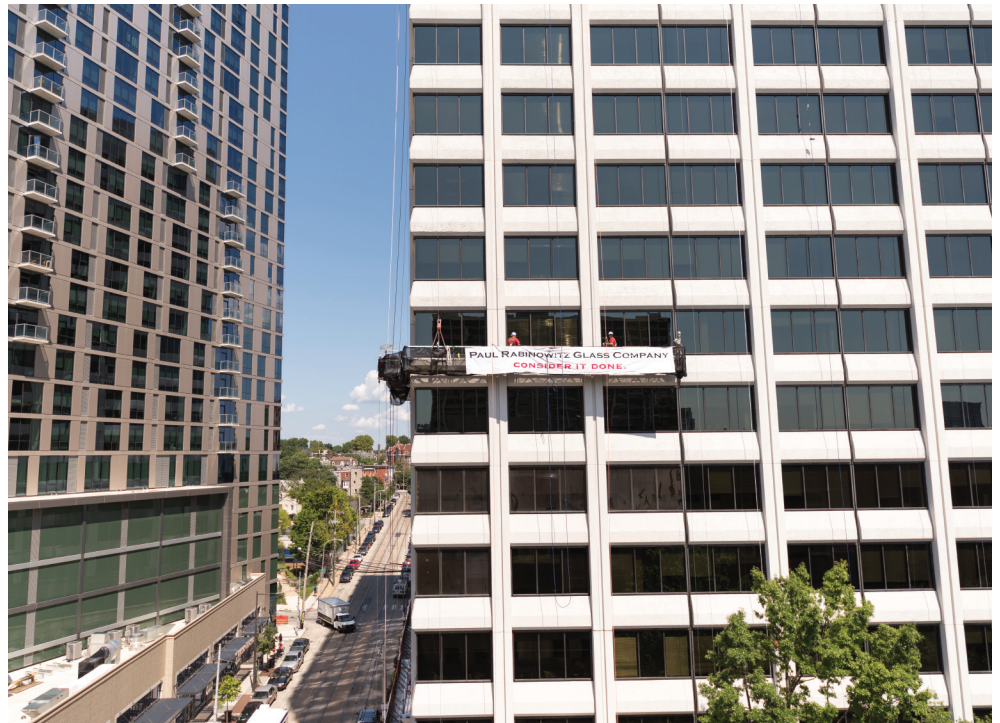
Window replacement underway at 3535 Market (all photos © Paul Rabinowitz Glass Co., Inc.)

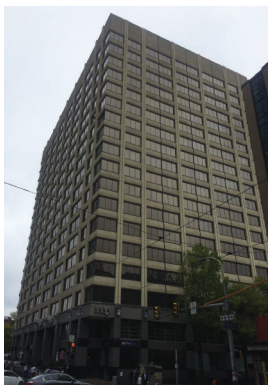
3535 Market Street before window replacement or exterior painting.

Paul Rabinowitz Glass Co., Inc. of Philadelphia, Pa., spent more than a decade providing glass replacement services at the building, working with longtime Senior Property Manager Lynne Williams, RPA. The existing single-pane glass featured a heavy solar film on the inside, but its age caused problems, and the highly reflective exterior looked dated. According to Williams, the windows were “always drafty” and the offices hot in summer and cold in winter.

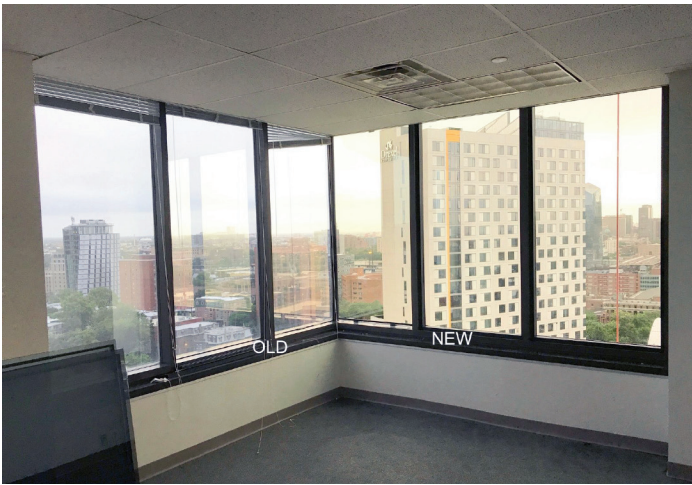
*Left: old single-pane glazing and new insulated glazing side-by-side, showing the improved light transmission; right: Rabinowitz glaziers installing the new glass on the freshly painted façade.*

Insulated glass provided three advantages at 3535 Market: an improved U-Value for better insulating quality, decreased reflectivity on the exterior for a contemporary appearance that complements the new building façade color, and greater visible light transmission and natural light in the building interior. J.E. Berkowitz fabricated the glass, which was manufactured by PPG.
