FORD FOUNDATION HISTORIC RENOVATION NEW YORK, N.Y.

Meticulous detail and new glazing for a landmark building.

CASE STUDY

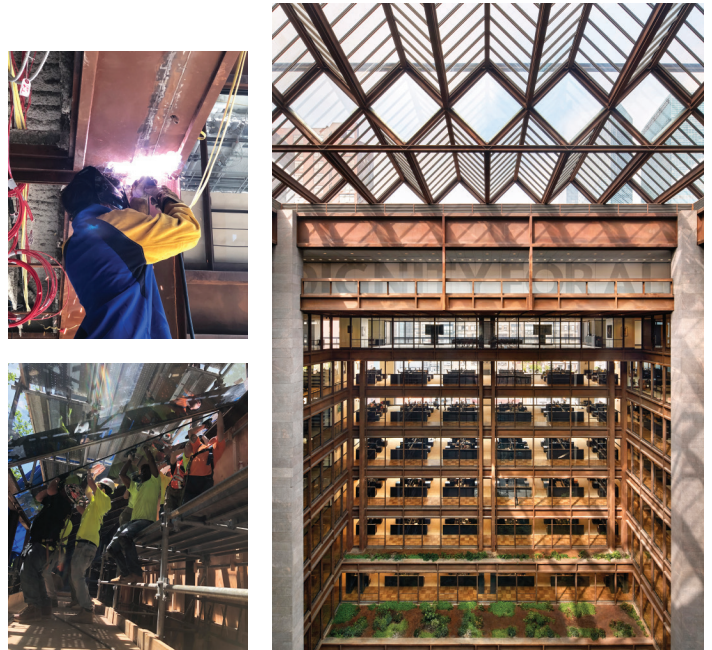
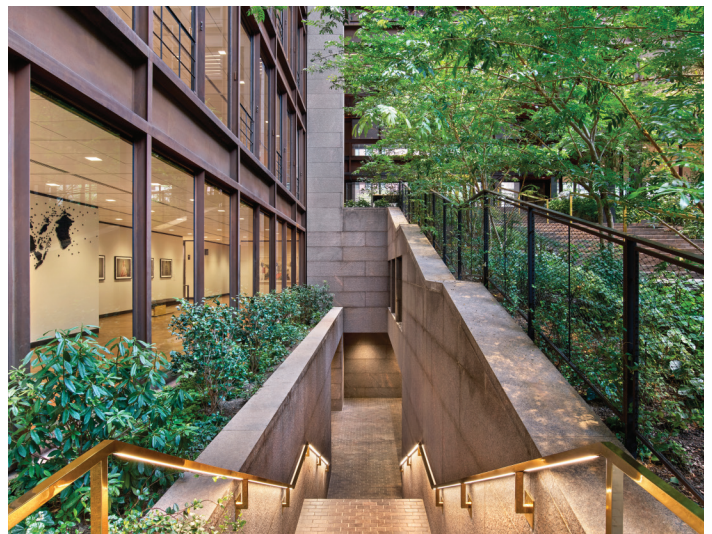
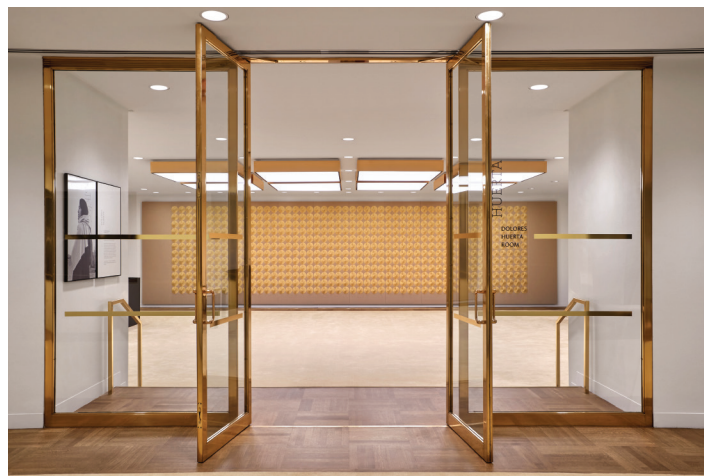
Clockwise: interior atrium showing roof/skylight system; garden loggia with new purge windows and lighted brass handrails; interior brass doors; the Beletz Bros. team setting glass from below; welding Corten

One of the building’s character-defining features is its sawtooth glass roof and skylight system, which spans the full footprint of the building above a full-height atrium. Beletz Bros. performed a complete restoration including removal, cleaning, and replacement of all gaskets, pressure plates, beauty caps, frames, and glass. LU252 glazier Andrew Mattie, who led the job, was fortunate to have original drawings for reference.

renovating the glass wall into a fully power-operated fire/smoke-purge window system. Each opening includes a subframe, window, and power operator finished to match the existing Corten steel. According to Beletz, the section was boarded up when the project began, to protect it from work taking place above. "When we first looked at the job, we couldn't see it," he explained. "But everything was rotted." A structural engineer prepared all new drawings and Beletz did the careful reconstruction to ensure the new work matches the original appearance.

The original building design featured dozens of brass doors in single and double sets. The renovation design preserved as many as possible. These were removed and brought to the Beletz Bros. shop where new hardware (either refurbished or new machined to match the original) was installed. Doors were stripped, polished, and re-lacquered, with minor welding as needed before being reinstalled. In situations where the old doors no longer met code, Beletz Bros. installed new custom center hung and balance doors that were fabricated to match existing framing. Hand artistry finishing techniques were used to replicate different shades of patina.
